## Site Inspection Report Summary

**Property Address:** 6231 PA-88 Finleyville, PA 15332

**Inspection Date:** 06/10/2020

## **Photo Report of Koteles Garage**

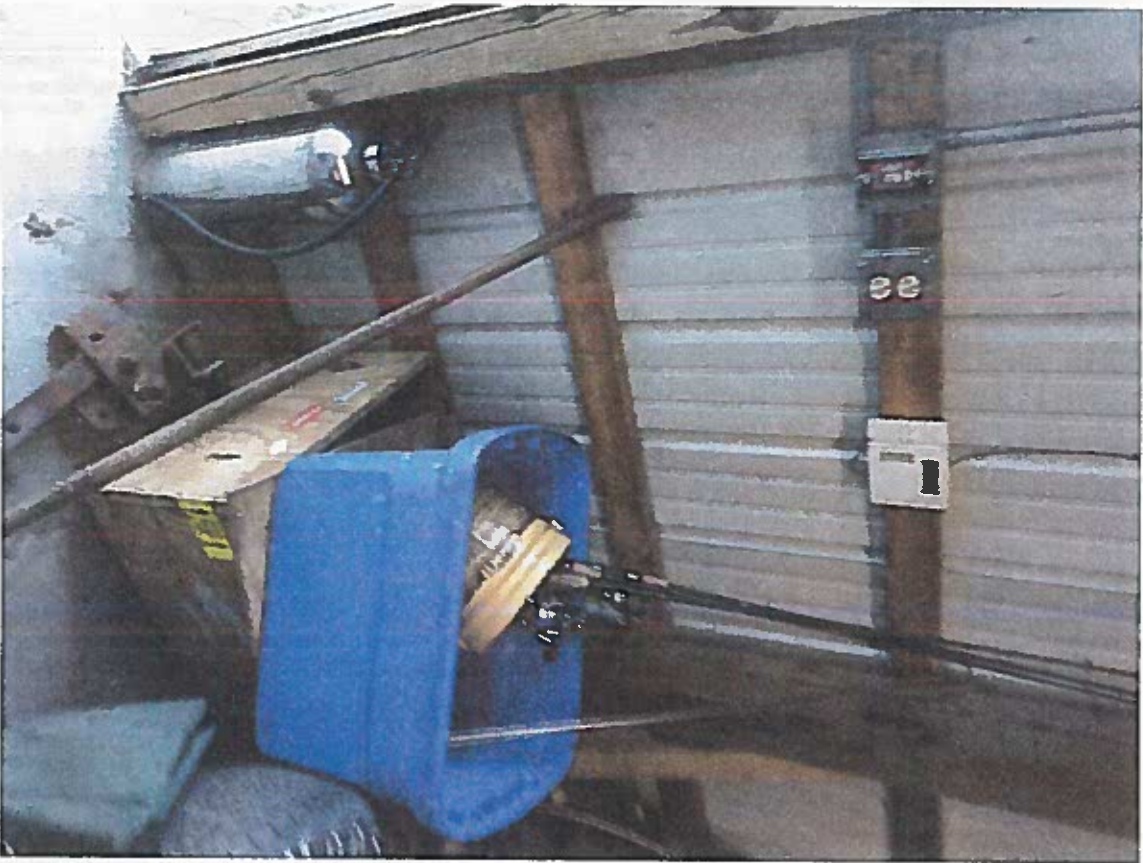
Missing light switch cover in rear white building. Old partially charged fire extinguisher.

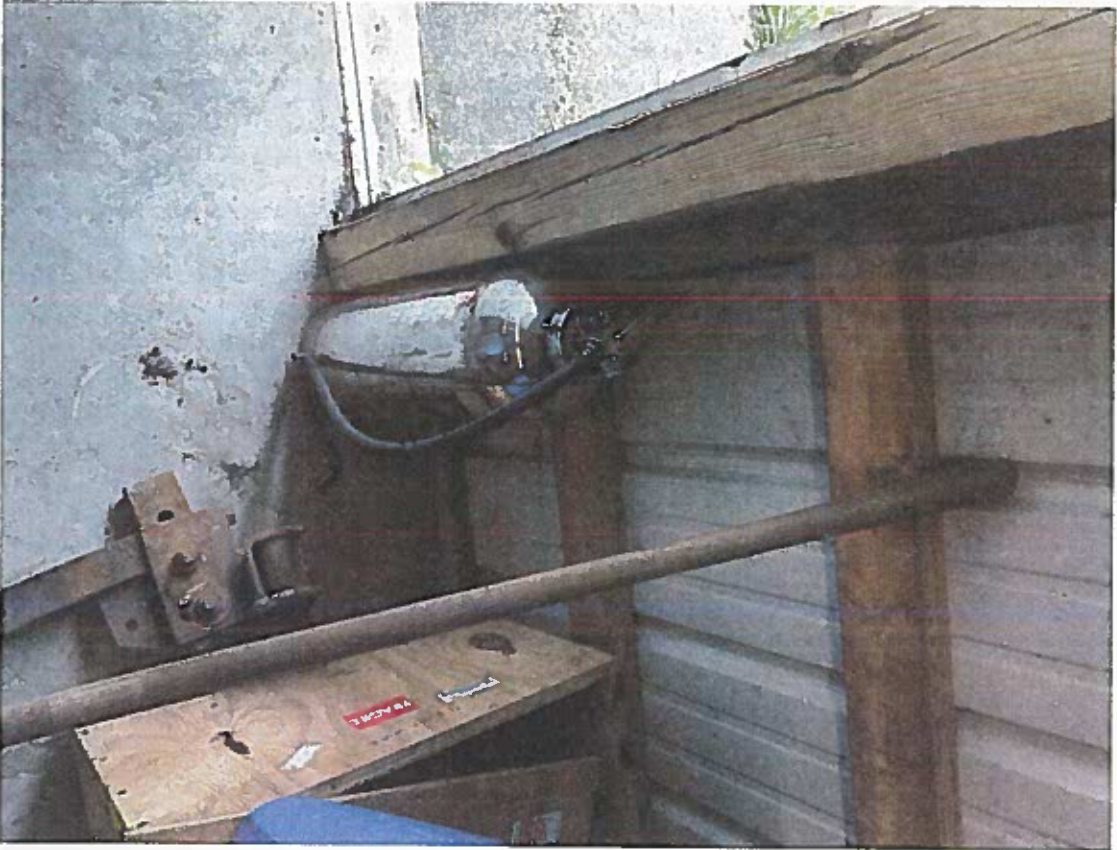
Old partially charged fire extinguisher. Only fire suppression found in rear white building. Where burn mark was found in ground outside adjacent to the structure.

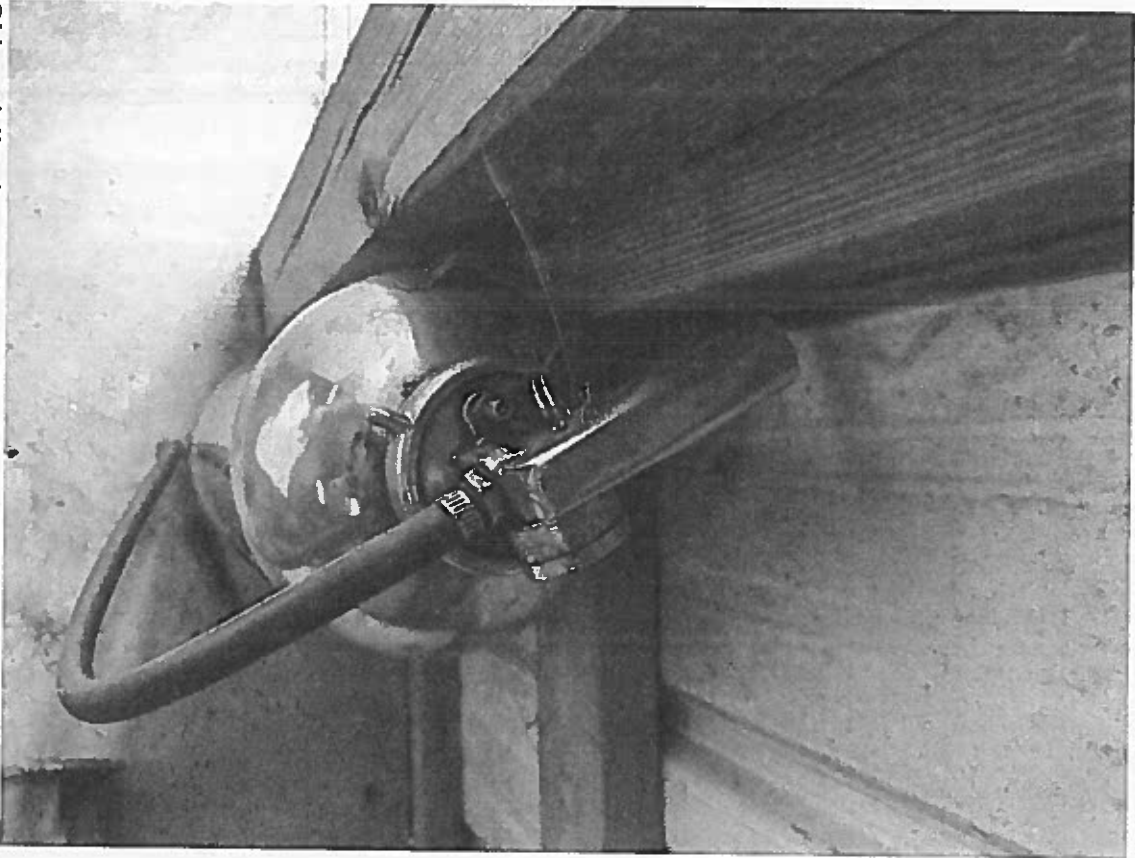
Old partially charged fire extinguisher. Only fire suppression found in rear white building. Where burn mark was found in ground outside adjacent to the structure.

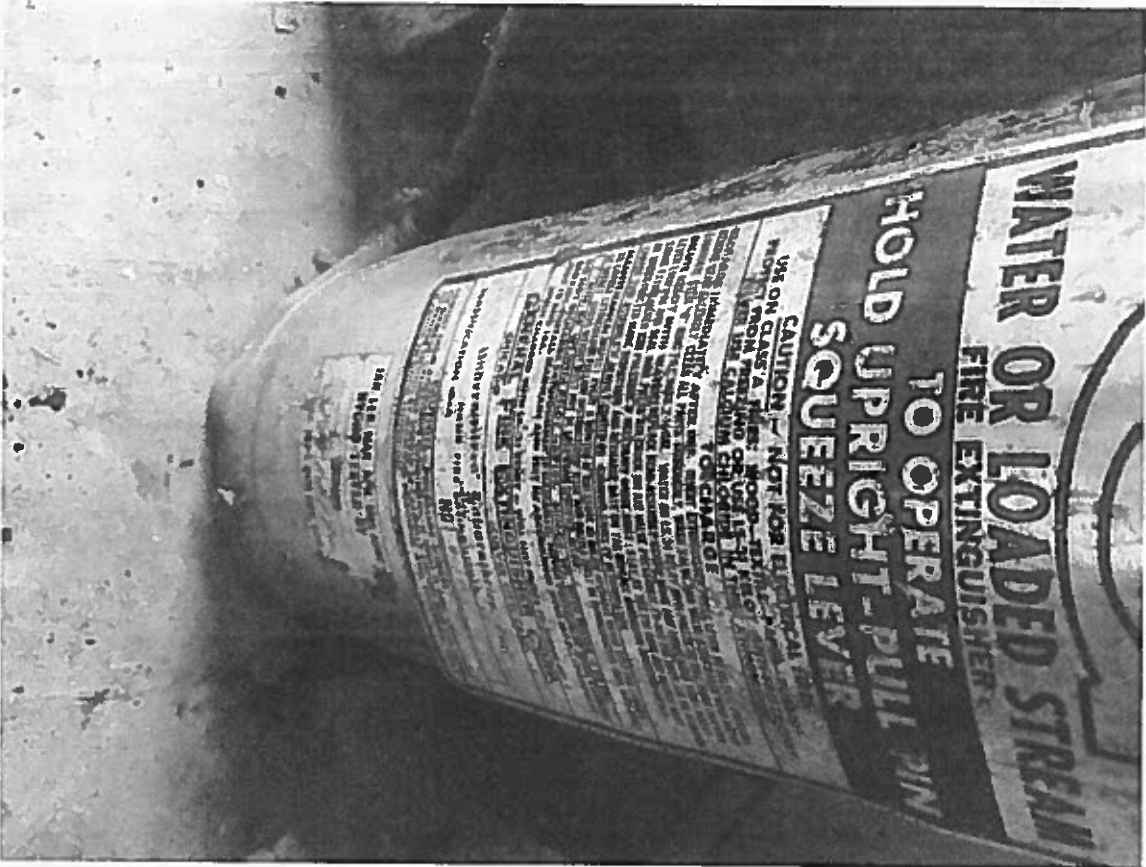
Old partially charged fire extinguisher. Only fire suppression found in rear building.

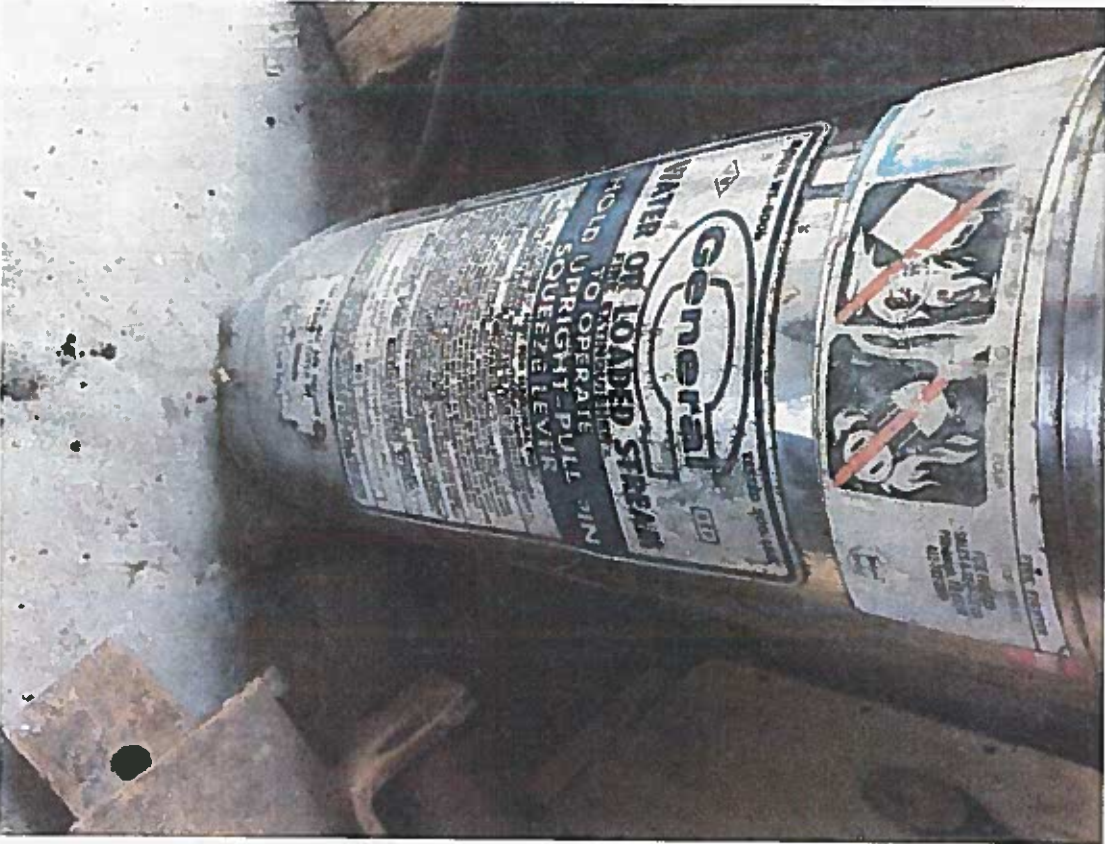
Old partially charged fire extinguisher. Only fire suppression found in rear building.

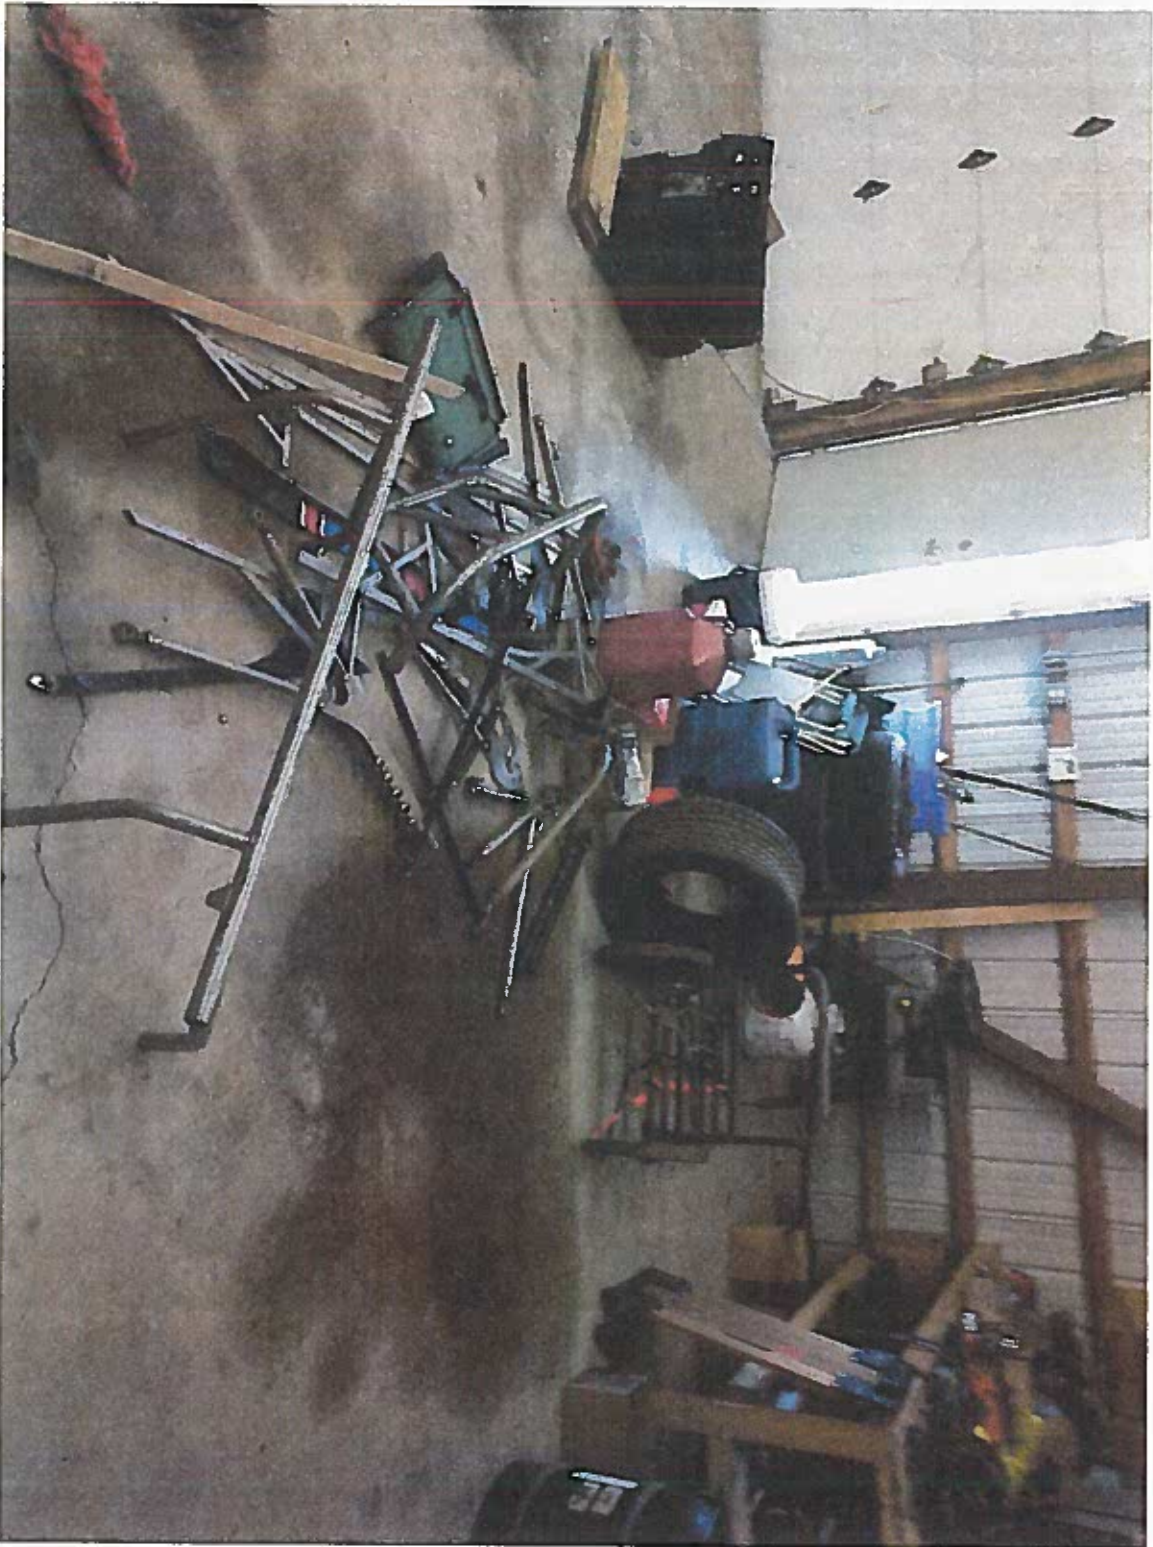
Oil stain and floor cracking in rear white building.

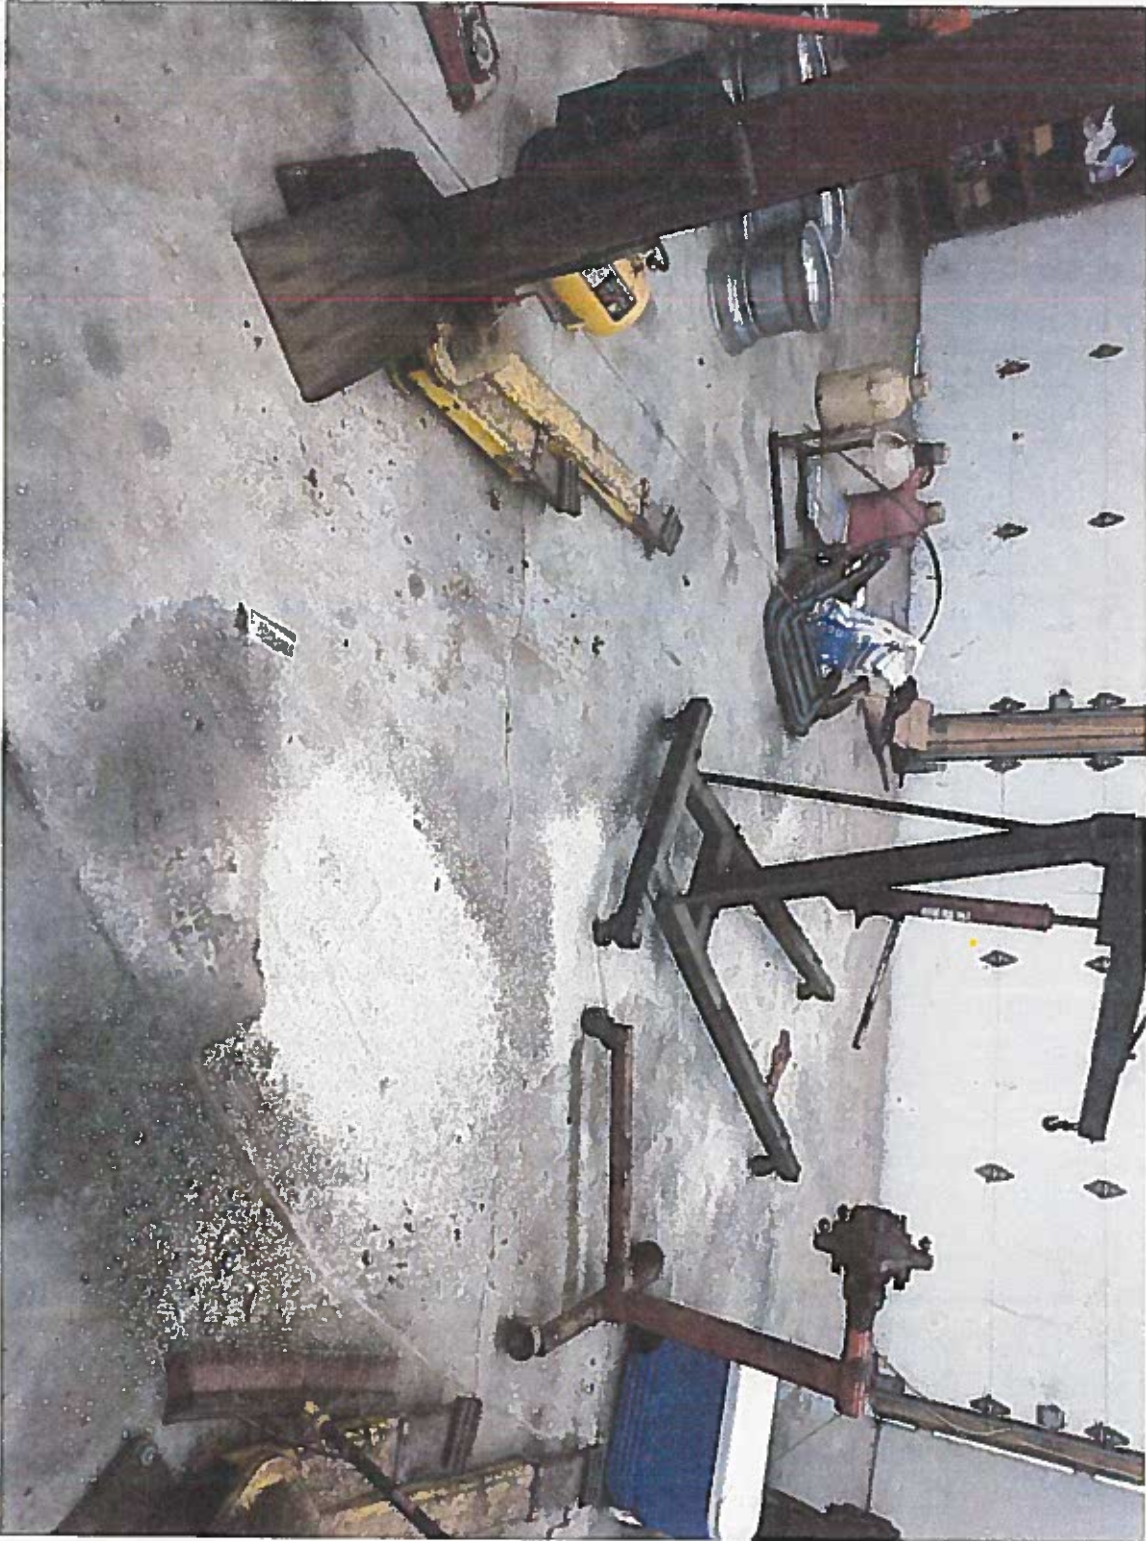
Oil spill absorbing material left on the floor in the rear white building.

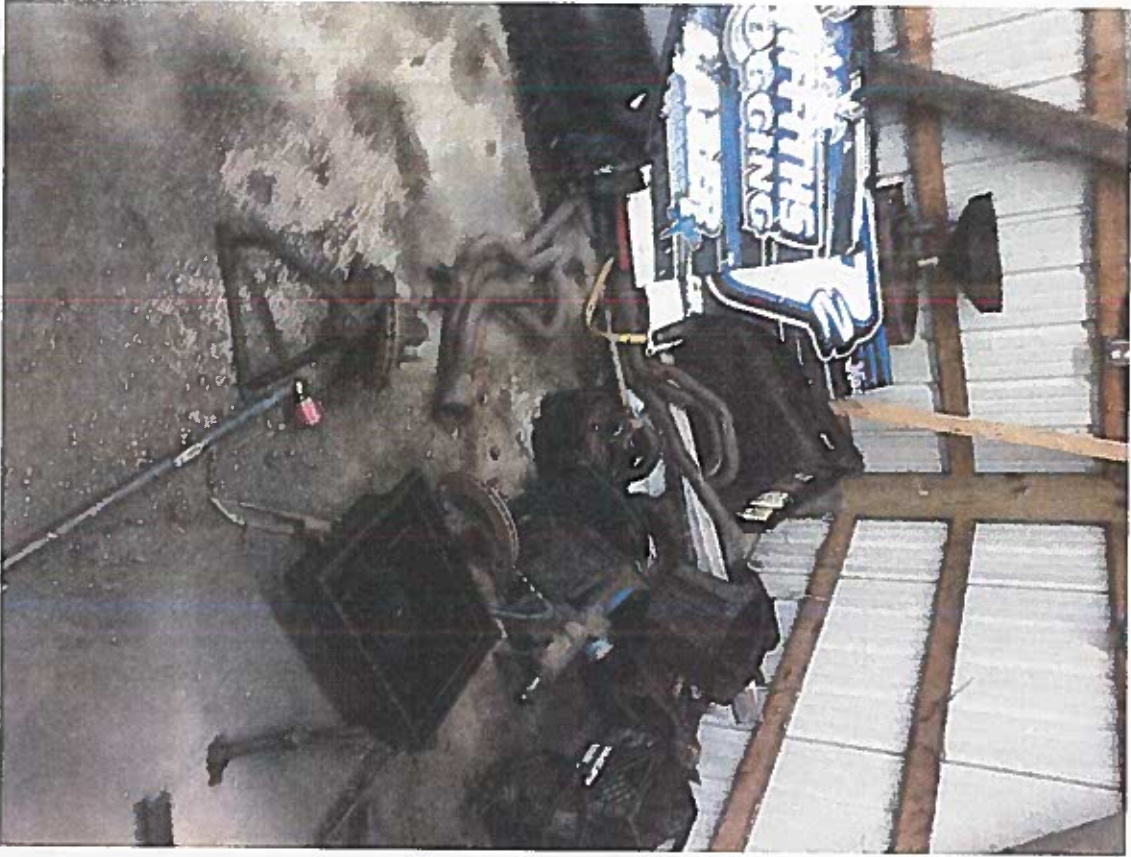
Open oil containers and oil spill absorbant material left on the floor.

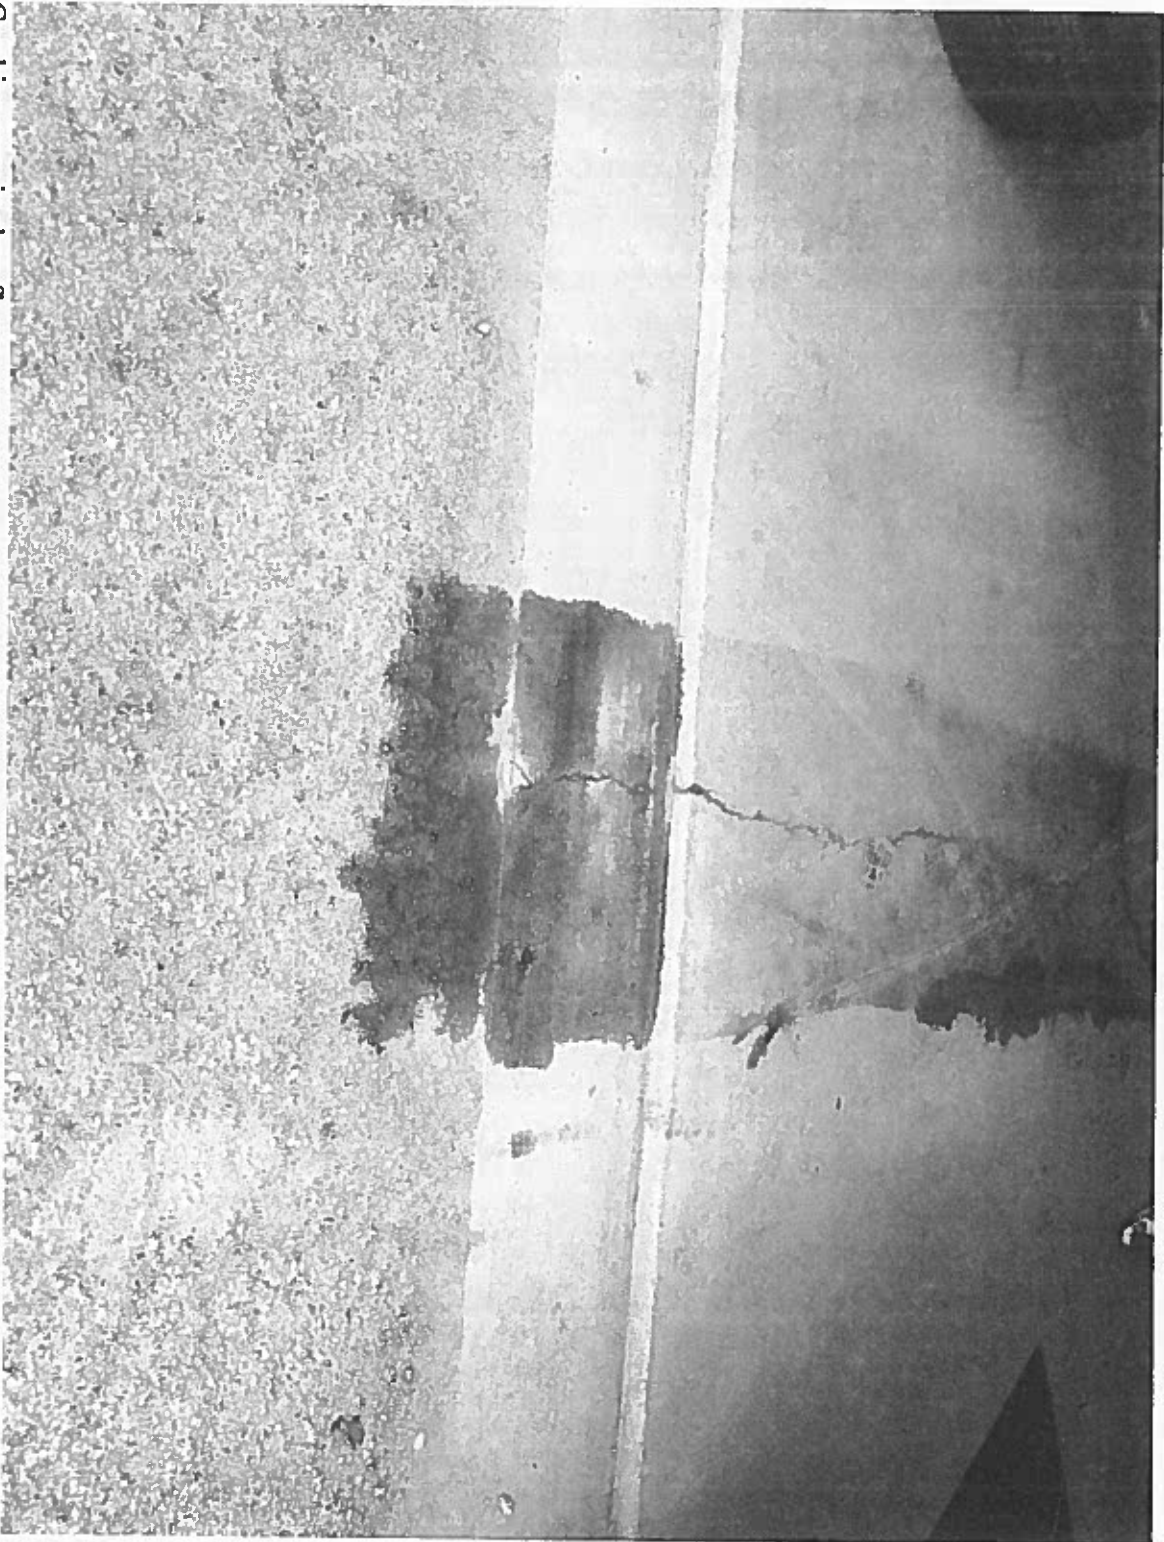
Cracking seen in shop floor area.

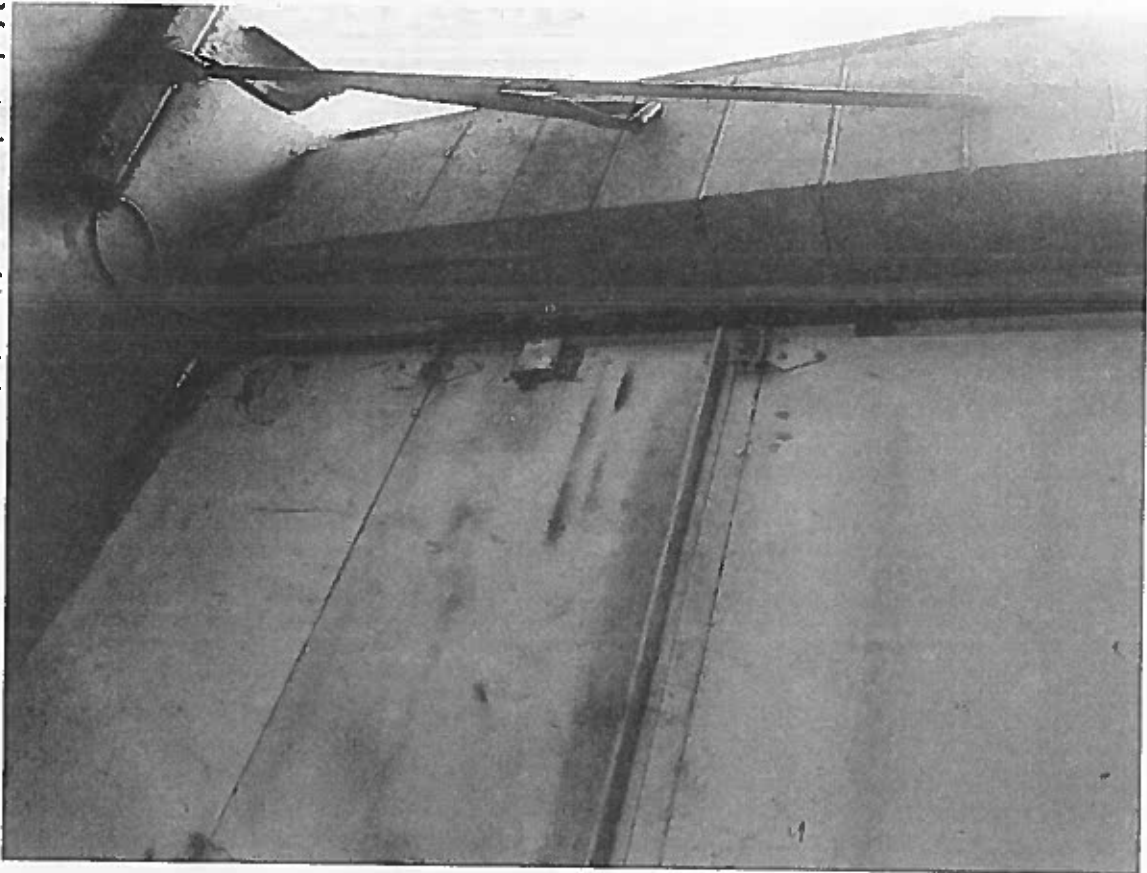
Moderate damage to this main bay garage door.

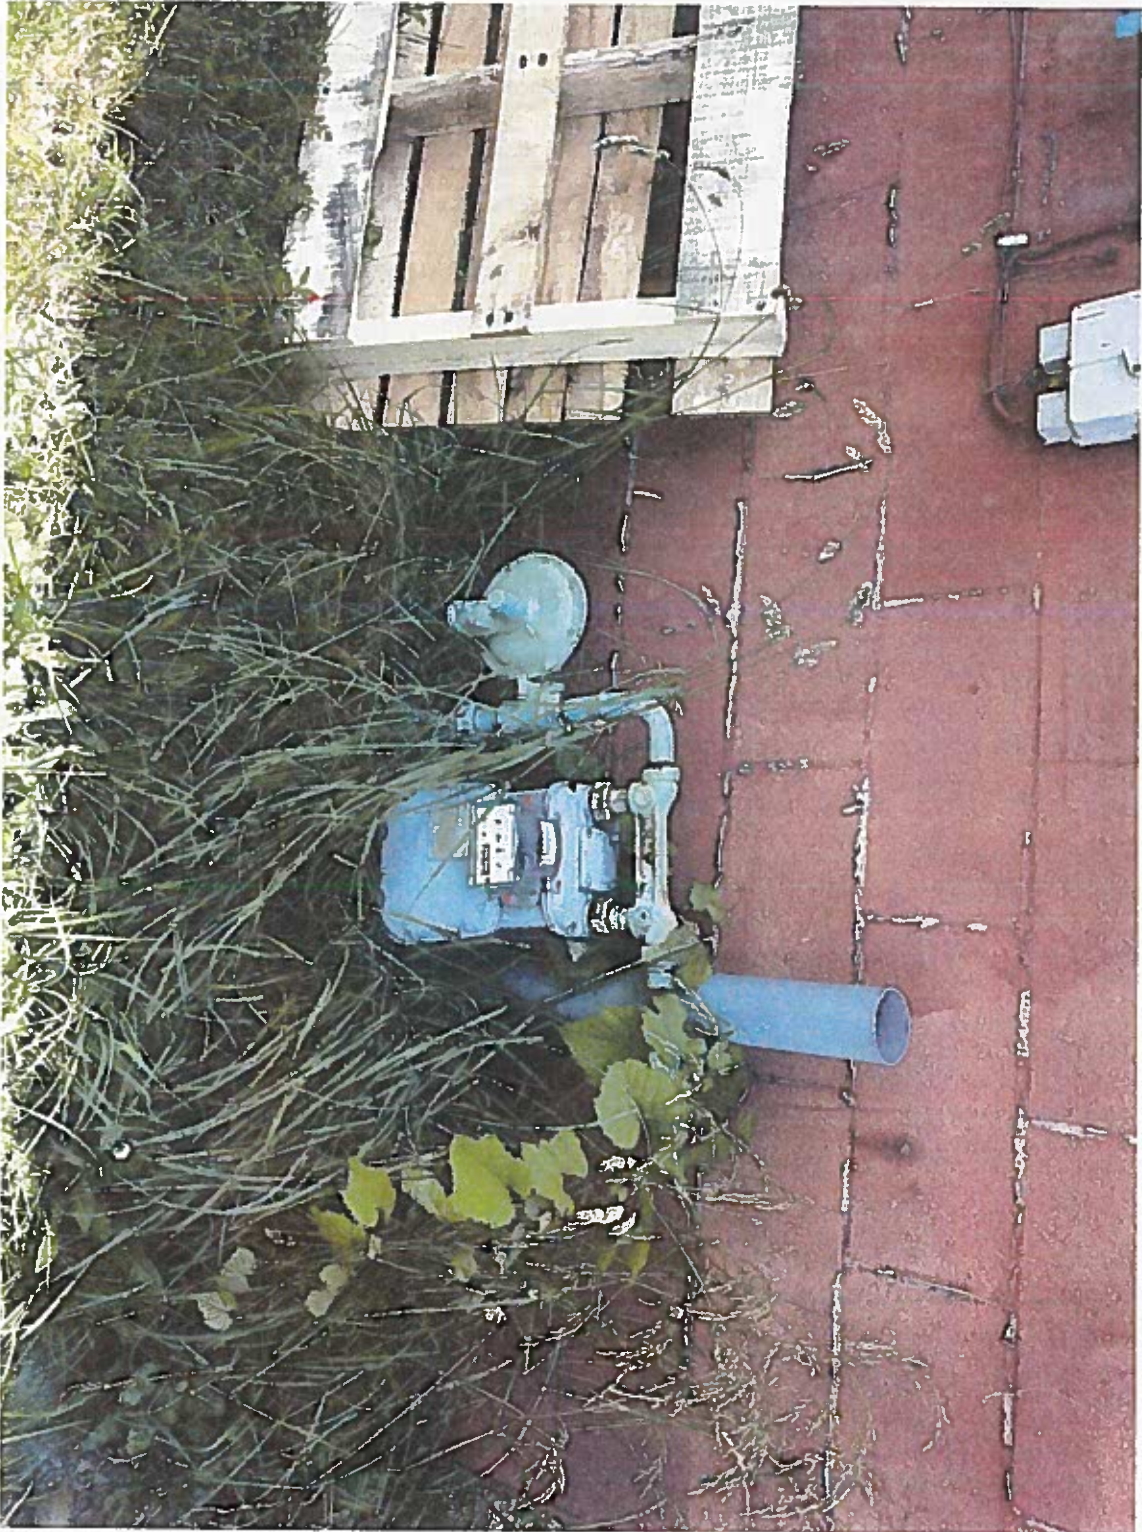
The plants near the property utility connections at the main front garage building needs trimmed.

Overgrowth and loose pallet near the property's utility connections.

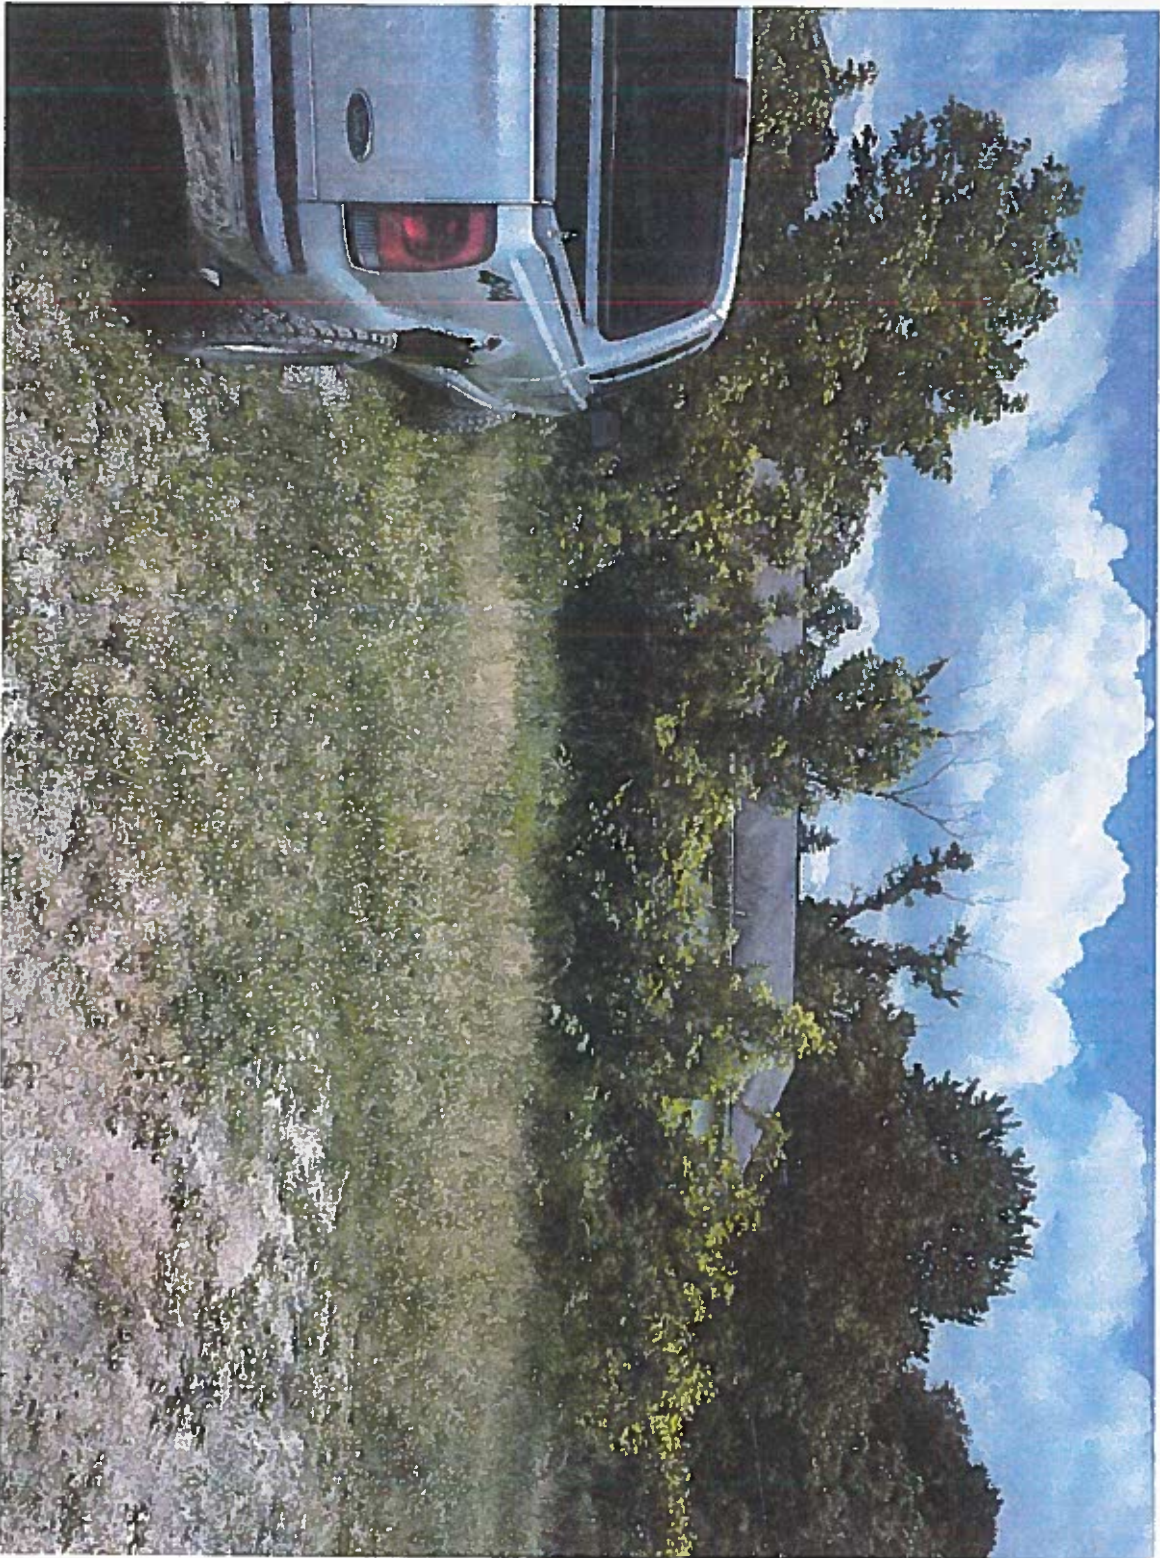
Overgrowth and weeds on the rear lot.

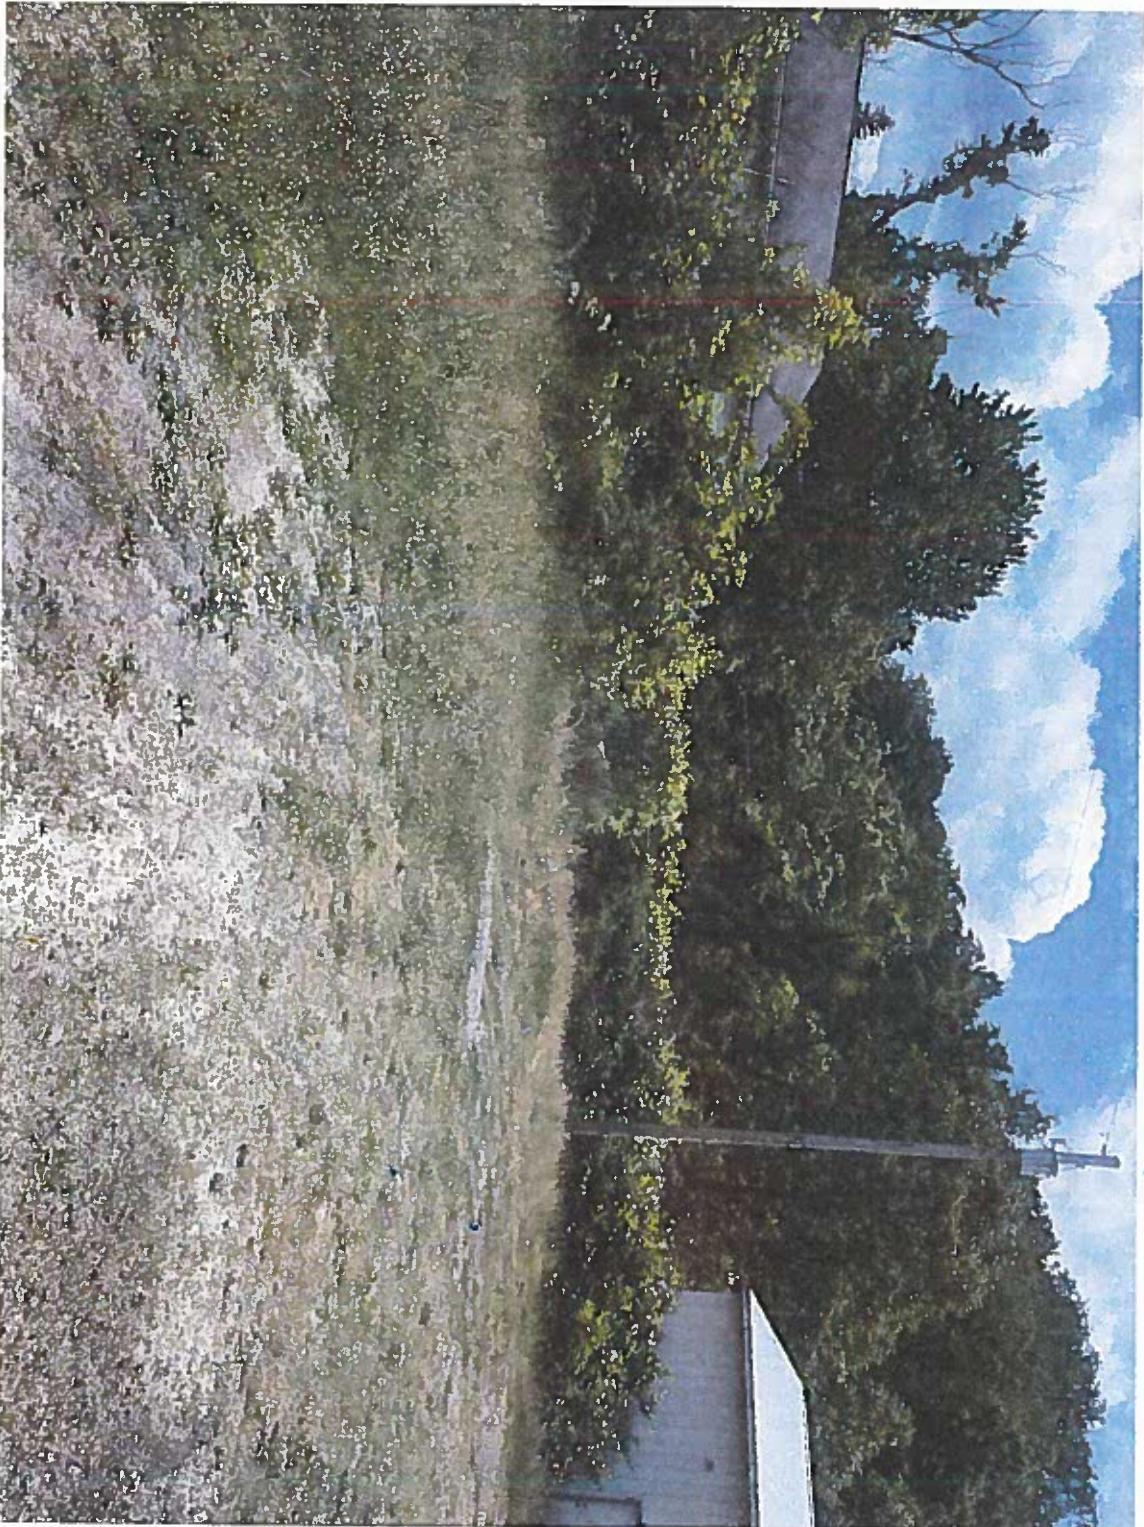
Overgrowth and weeds on the rear lot.

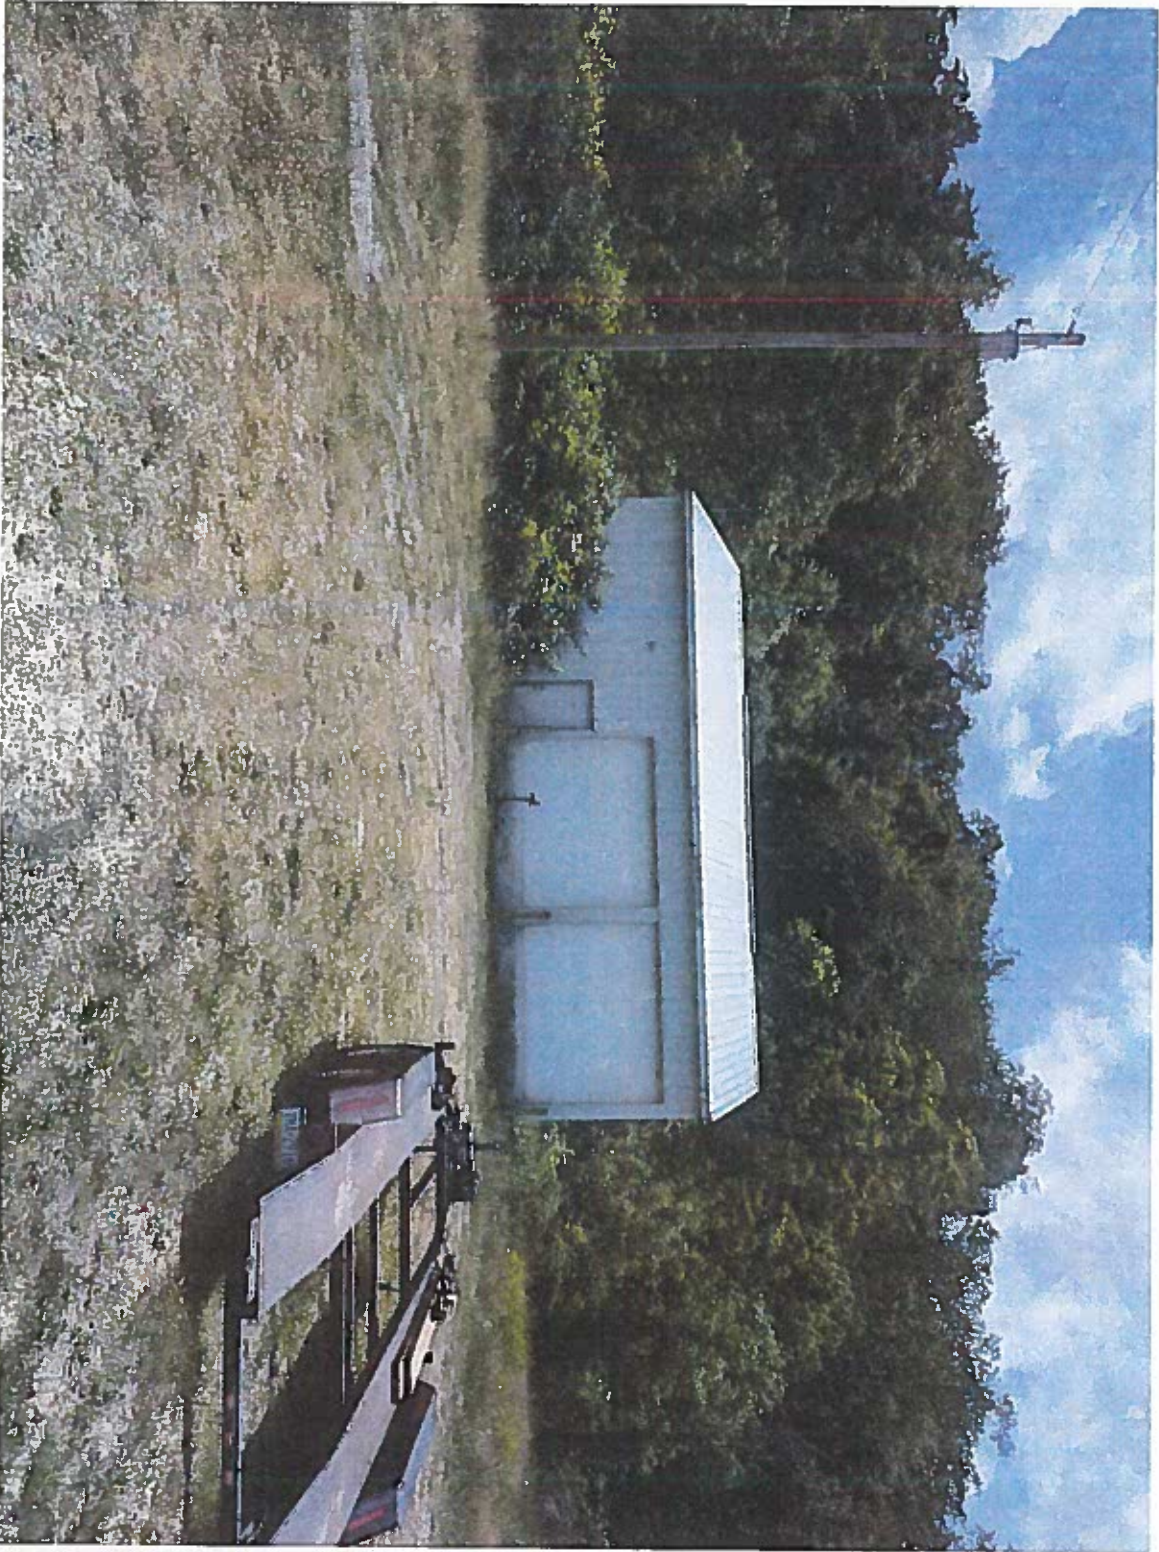
Overgrowth and weeds on the rear lot.

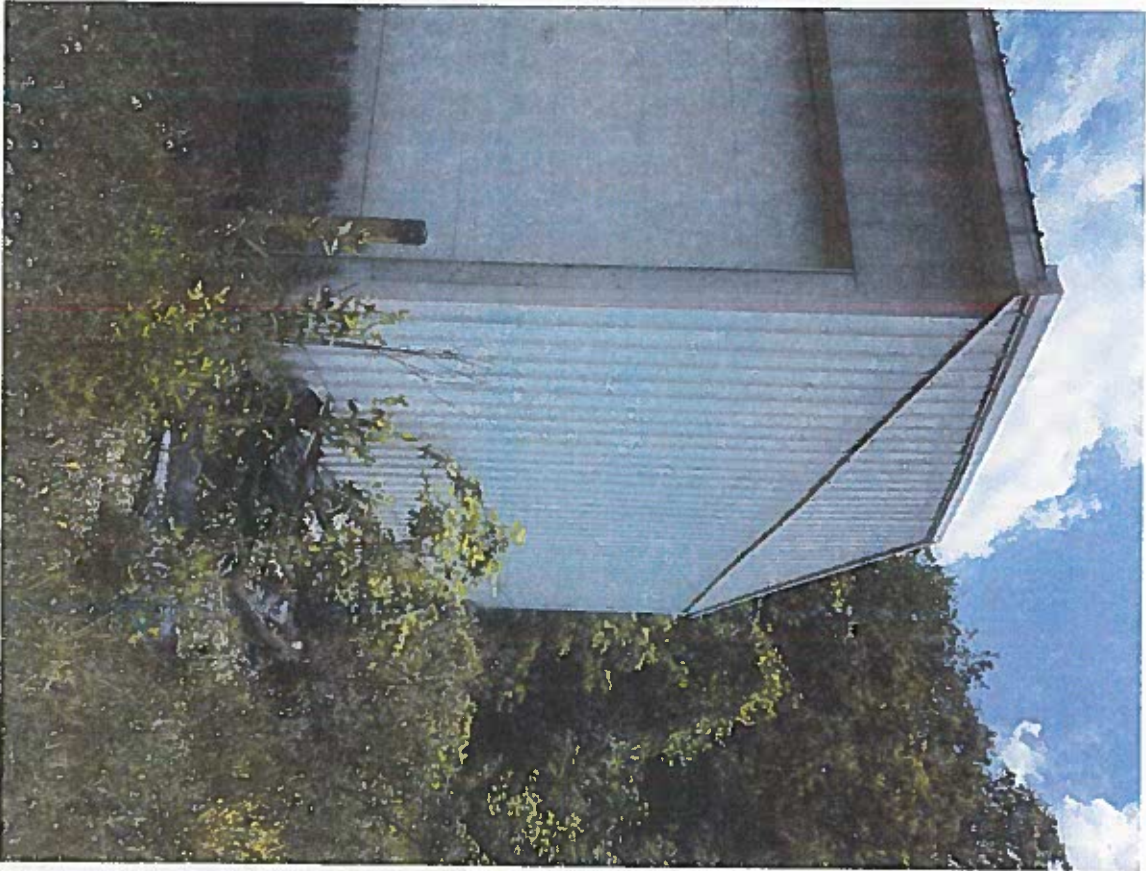
Overgrowth and weeds on the rear lot.

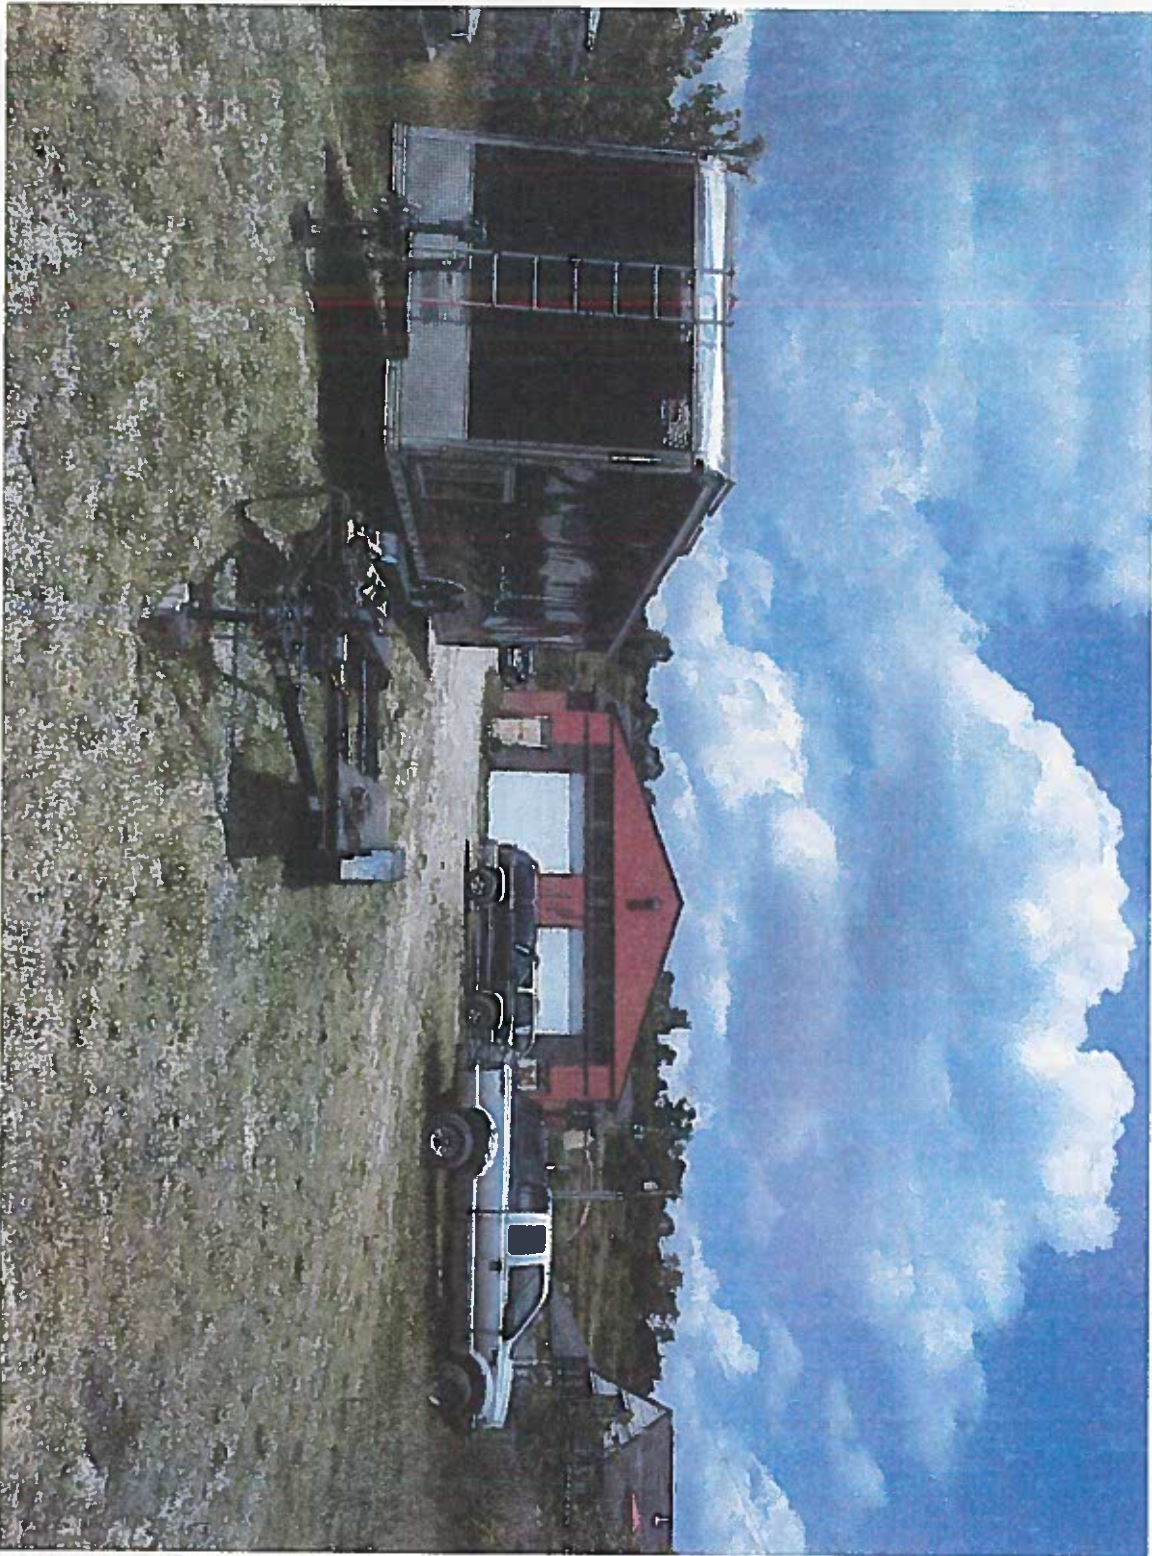
Overgrowth and weeds on the rear lot.
